PROTECTION OF MOORING BUOYS

PART VI. RESULTS OF FIFTH

RATING INSPECTION

U. S. NAVAL CIVIL ENGINEERING LABORATORY

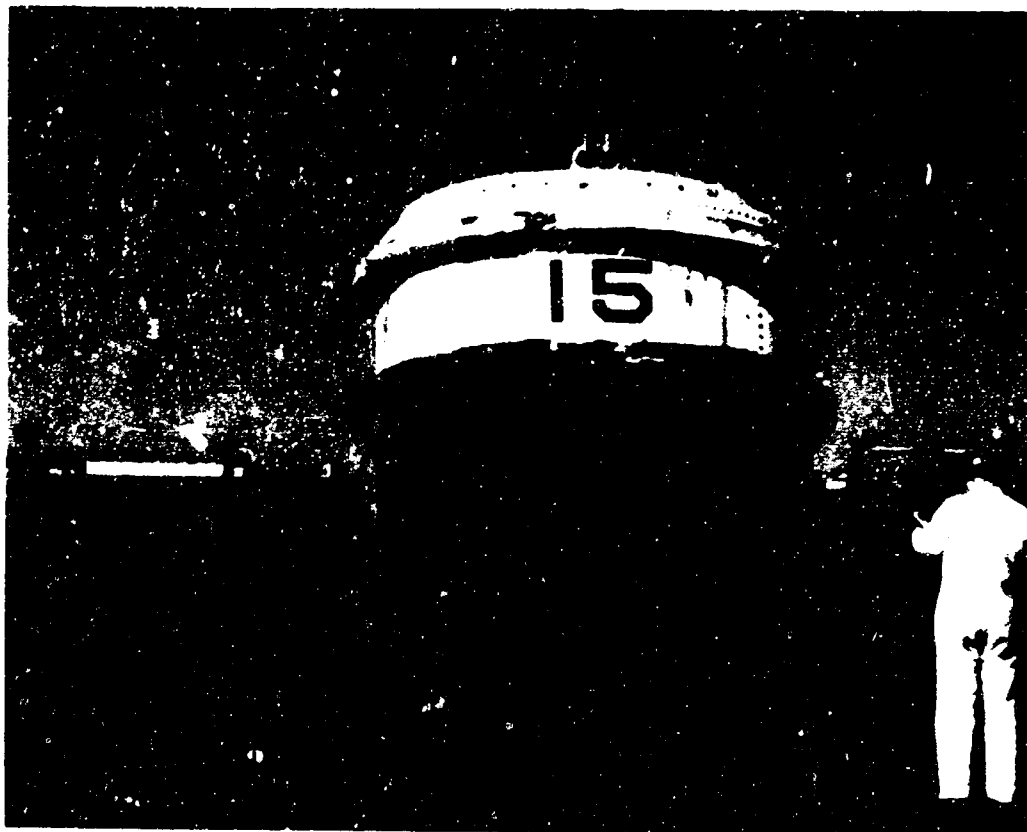
Coating System 3: Epoxy - Polyester. The condition of the Coating System 3 buoy (Figure 5) was essentially the same as that noted at the time of the previous inspection. The epoxy primer exposed in the submerged zone, where some of the polyester topcoats had delaminated, was continuing to protect the underlying steel. The other slight coating damage in all three zones was related to abrasion. There was considerable localized Limnoria attack under the lower fender.

Figure 5. System 3 buoy before removal of fouling.

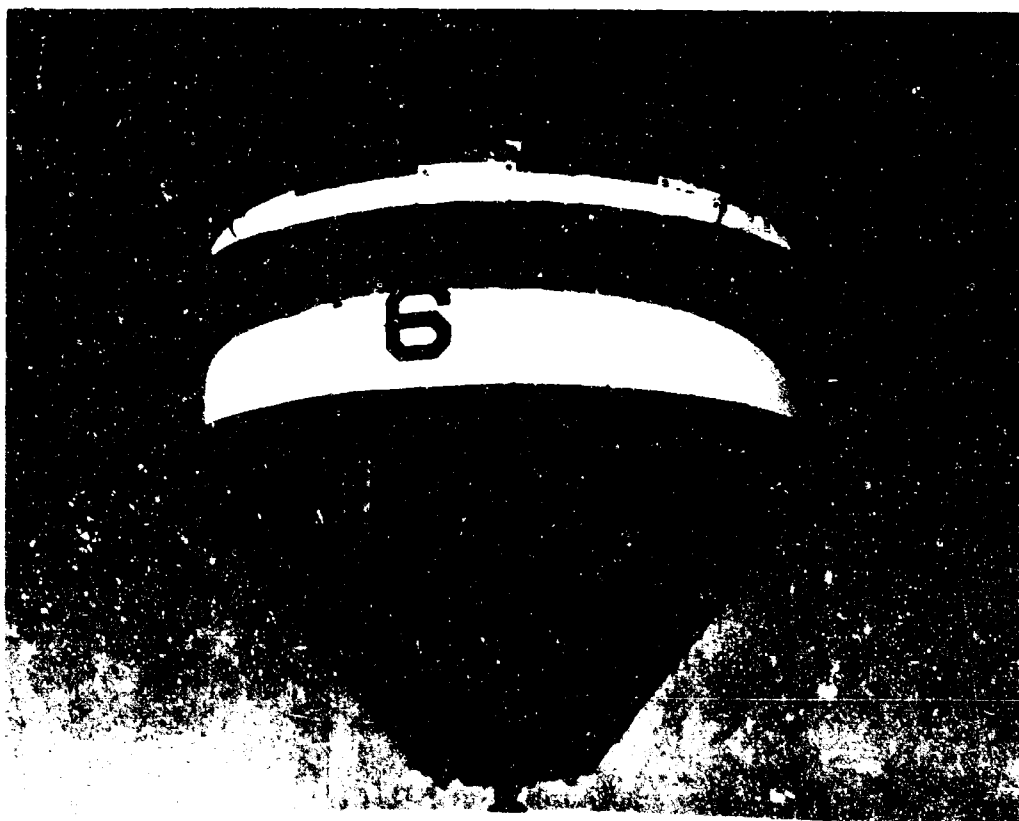
Coating System 4: Epoxy - Coal Tar Epoxy. The condition of the Coating System 4 buoy (Figure 6) was essentially the same as that noted at the time of the previous inspection. The previously reported delamination of the topcoat and seal coat in the submerged zone had not advanced significantly, and the underlying epoxy primer and coal tar epoxy were providing good protection to the steel.

Figure 6. System 4 buoy showing delamination of seal and topcoats in submerged zone.

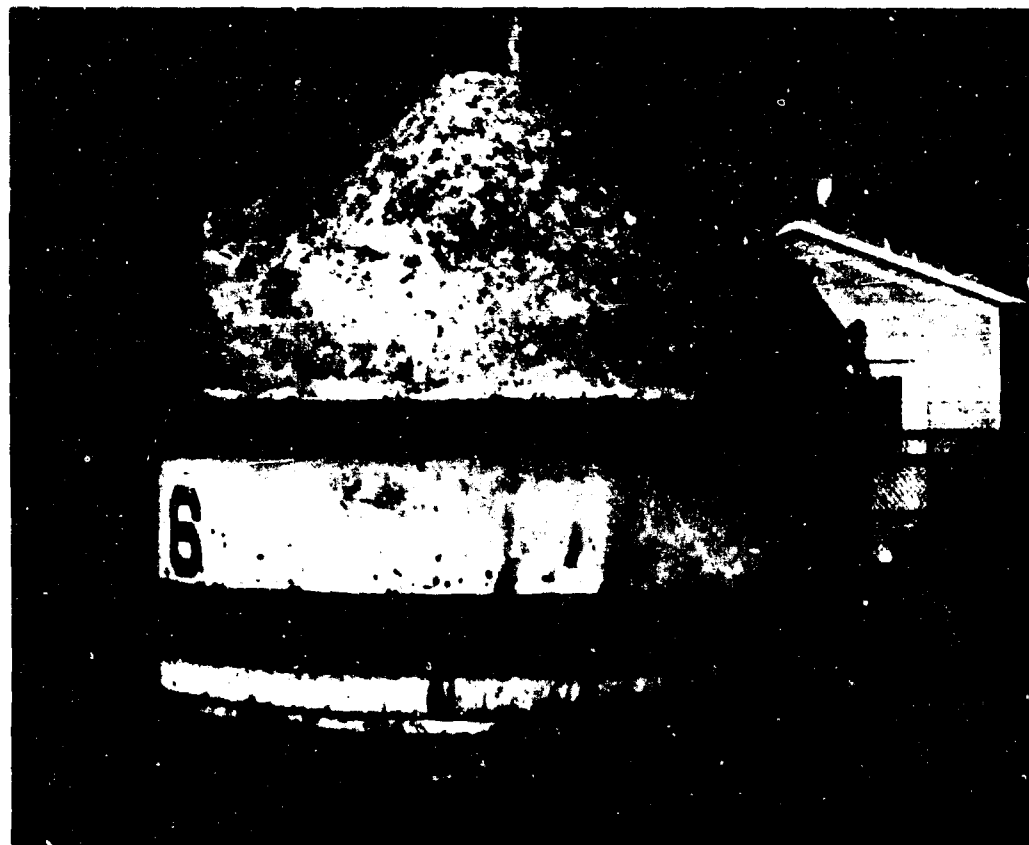
Coating Systems 6 and 6C: Phenolic Mastic. Coating System 6 and 6C were identical, but the 6C coating was applied to a cathodically protected buoy. The condition of both buoys (Figure 8) was almost the same as that noted at the time of the previous inspection. The slight damage to both buoys had been caused by impact and abrasion of ships and mooring lines. The previously reported galvanic corrosion on the System 6 buoy had not advanced to any significant extent. The lower wooden fender on this buoy had slight Limnoria damage.

Figure 8. System 6C buoy ashore during relocation.

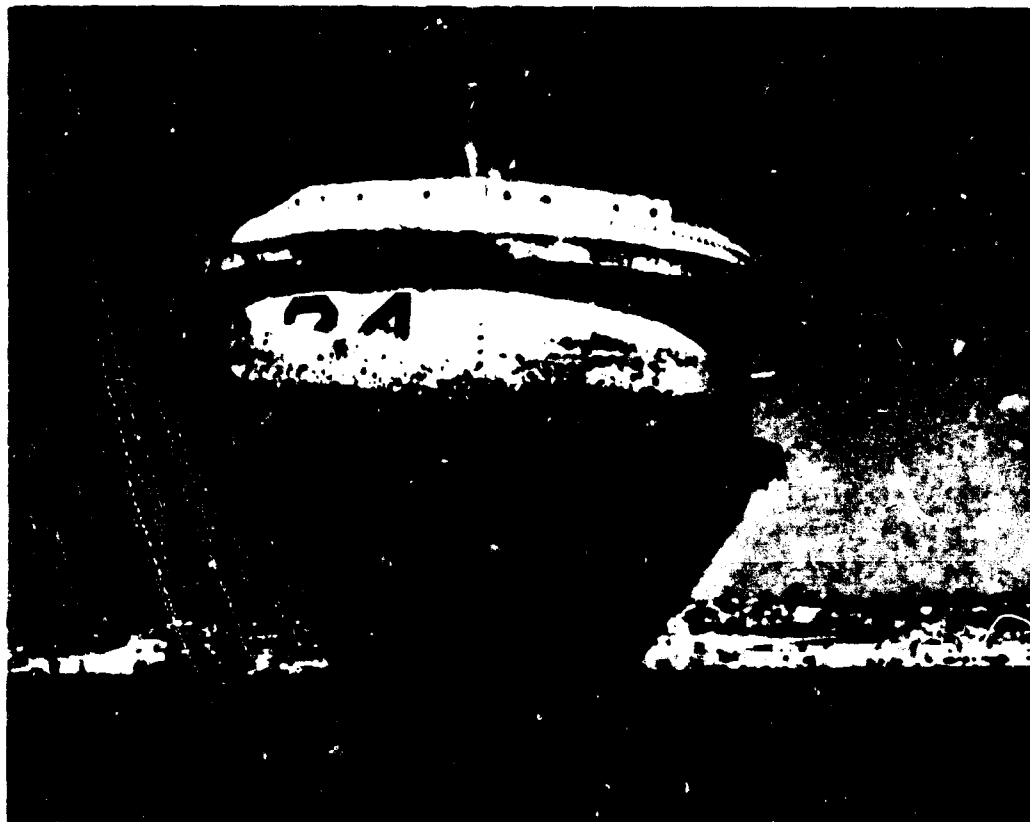
System 9: Vinyl. The condition of the System 9 buoy (Figure 13) was essentially the same as that noted at the time of the previous inspection. The very slight coating damage previously reported was caused by abrasion. The antifouling coating had eroded in the submerged zone, exposing the primer in several places. The light fouling on this buoy was similar to that on buoys in this area without an antifouling paint. There was extensive localized Limnoria attack on the lower wooden fender (Figure 14).

Figure 13. System 9 buoy after removal of fouling.

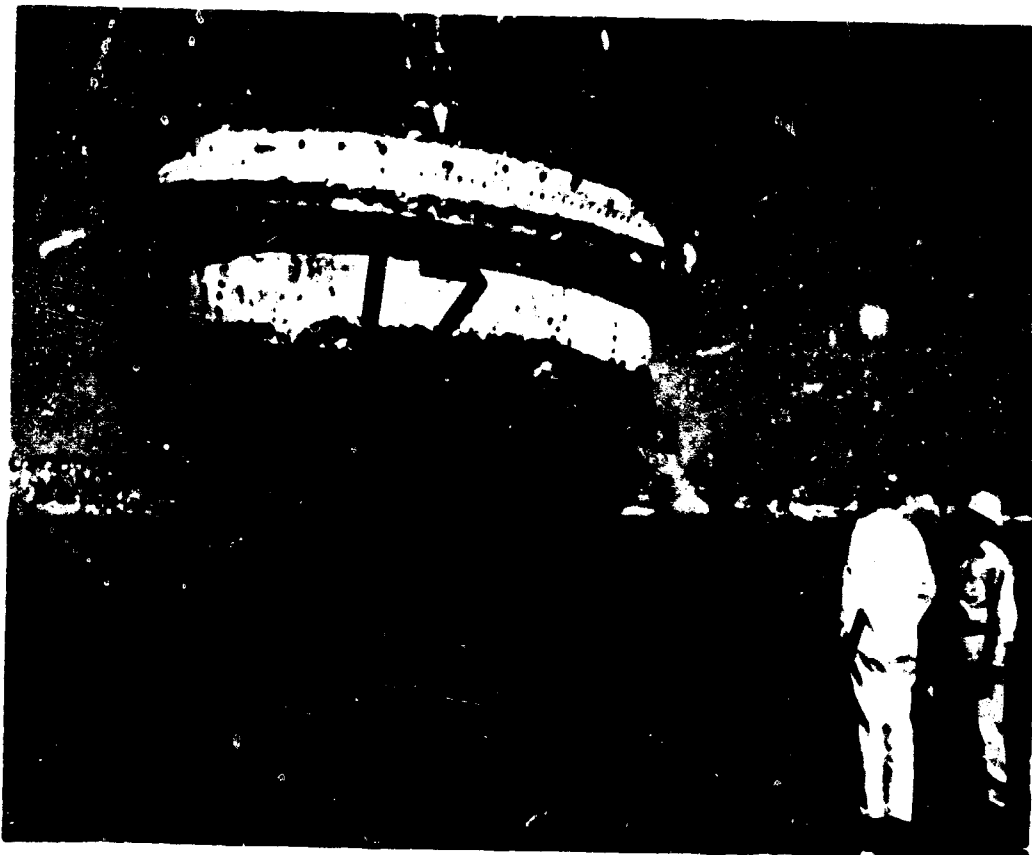
System 10: High-Body Vinyl. The condition of the System 10 buoy (Figure 15) had deteriorated only slightly from that noted at the time of the previous inspection. There was abrasion damage on the top and pinpoint rusting (Figure 16) and blistering on the side. In the submerged zone, there was some rusting initiated by abrasion and some galvanic corrosion of abraded rivet heads.

Figure 15. System 10 buoy before removal of fouling.

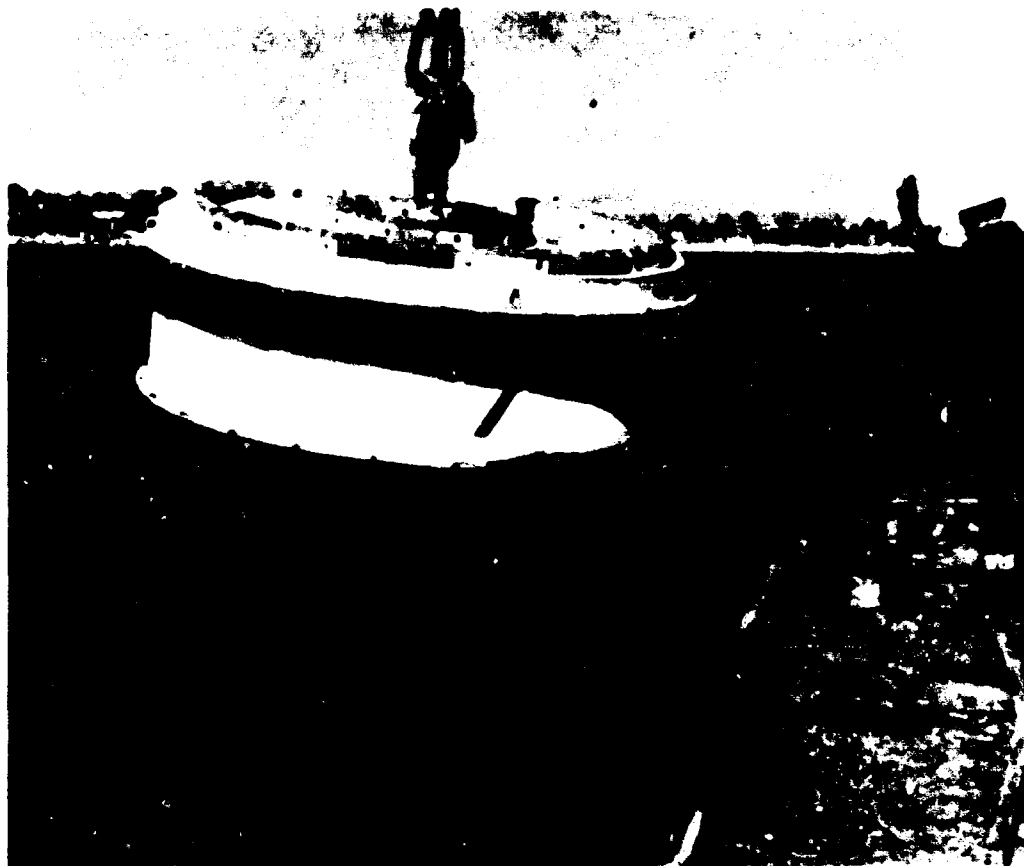
System 12: Inorganic Zinc Silicate - Vinyl Mastic. The condition of the System 12 buoy (Figure 17) had changed little since the last inspection. There was very little rusting on the top and side, all caused by abrasion. In the submerged zone, about half of the primer and topcoat had been lost after 6 months of service. Two years later, the exposed inorganic zinc silicate was still preventing corrosion. There was relatively little fouling on this coating as compared to that on the topcoat.

Figure 17. System 12 buoy on which fouling had been previously removed during relocation.
